Smarter Suffolk Project

Gully Sensors Final Report

Hannah Steventon
Issue 1.0 February 2022

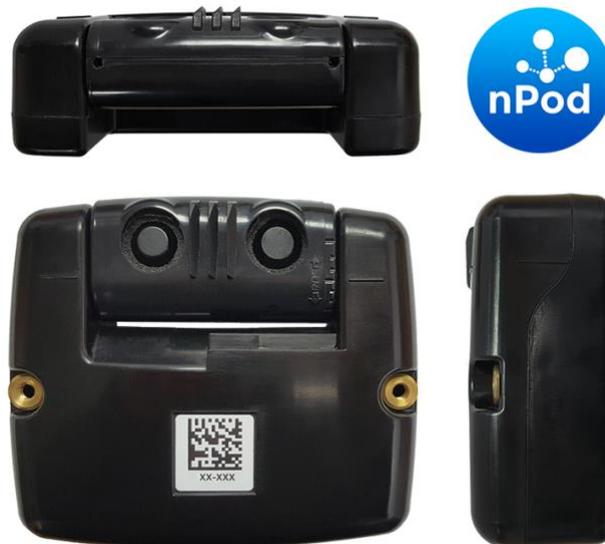
The sensor provided by KaarbonTech is the Farsite Liquinet (understood to be identical to the Farsite Netbin nPod sensor) which measures depth to water level (or other surface) in the gully. Vendor documentation is included in a digital archive for this report. The sensor is pictured in Figure 1. Its dimensions are approximately 140mm x 122mm x 46mm, and it has a rotatable sensor housing.

Figure 1: Farsite liquinet, image from <https://iot.farsite.com/products/liquinet-flood-sensors/> 02/04/2020

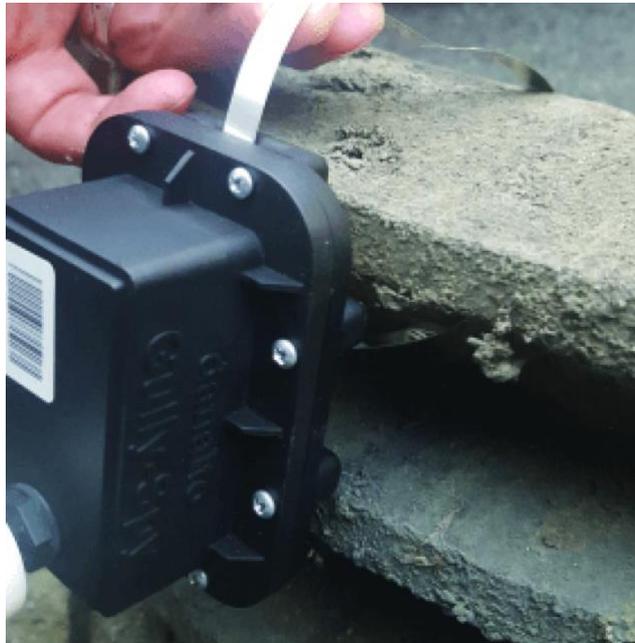
The Danalto Gully Spy is a small (92x63x48mm) overflow sensor, using a capacitive sensor to identify flood conditions. Vendor documentation is included in a digital archive for this report. It is shown in Figure 2.

Figure 2: Danalto Gully Spy fitted to a gully at Adastral Park. Photo H Steventon

The sensor is quickly attached to the gully grate by two metal ball-lock cable-ties (recommended are HellermanTyton MBT14HS ties) to the gully grate. The sensor should be attached in the centre of the grate.

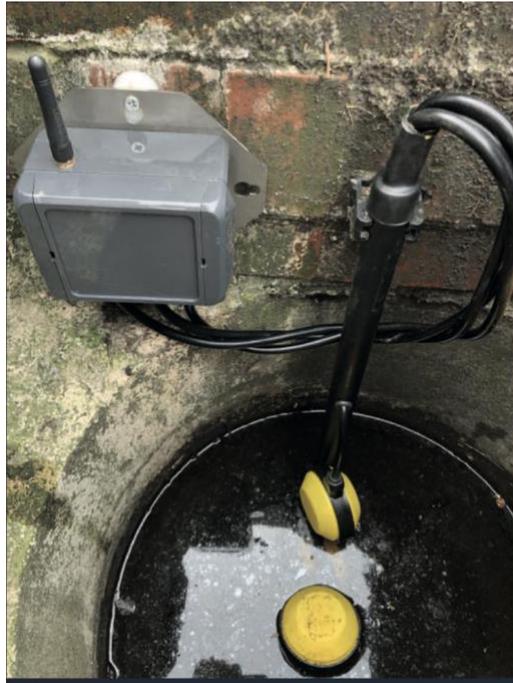
Map16 Gully Sensor detects water levels in the gully pot using a number (usually three) of float switches positioned to detect water at 25% full, 50% full and outfall level. It is described as measuring “empty, low, blocked at connection, and high”. Map16 claim that modelling within their software can calculate silt level based on the water level, using previous observations, weather data and local knowledge. This sensor is pictured in Figure 4; it is approximately 122mm x 122mm x 114mm in size with attached probe with float switches. The sensor does not measure above outfall flood, light levels or precise depth to water in the gully. It is described as requiring no calibration or adjustments, as the sensor depths are determined at installation.

Figure 4: Map16 gully sensor, image from data sheet

The gully sensor attaches to the gully wall using screws into the gully wall. Installation is described as ‘quick and easy’ in less than 15 minutes, using ‘high grade 216 stainless steel mounting hardware’. The ultrasonic sewer sensor is mounted to the sewer cover, using industrial grade neodymium rare earth magnets.

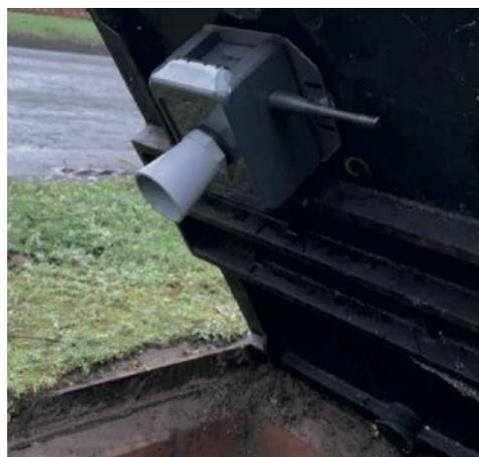
The Map16 ultra sonic sewer sensor measures depth to water in the sewer. The sensor is pictured in Figure 5, it is approximately 122mm x 122mm x 114mm in size, with a protruding conical cover for the sensor housing. The sensor does not measure flood, light levels or silt levels.

Figure 5: Map16 sewer sensors, image from data sheet

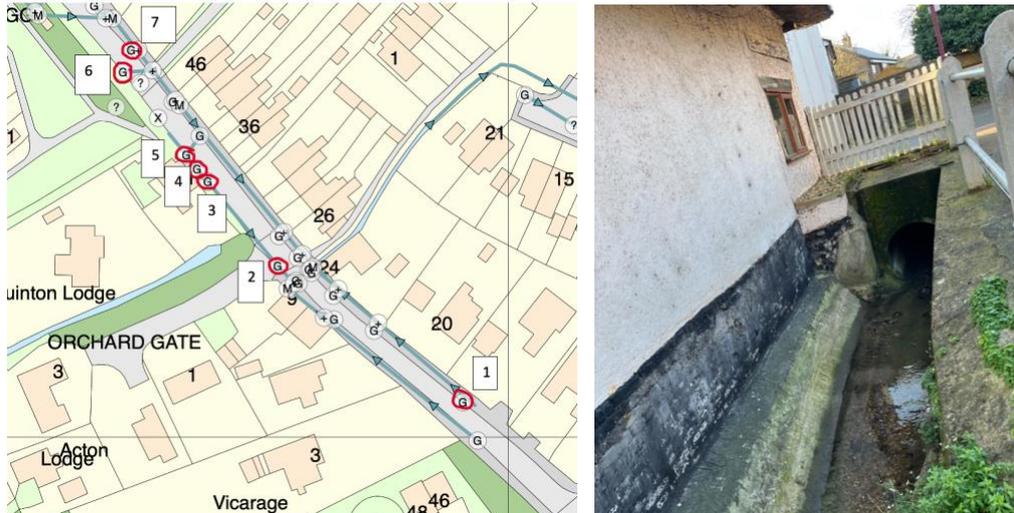
Seven sensors were installed on High Street, Needham Market, at locations selected by SCC drainage team. These locations are shown in Figure 8, using data from KaarbonTech Asset Management System to resolve discrepancies in the two dashboards.

Figure 8: Locations of KaarbonTech Gully Sensors, Needham Market. Gully locations indicated with red circles and numbers (Base image from KaarbonTech Asset Management software, annotated by H Steventon based on data from KaarbonTech Asset Management System and KaarbonTech Liquismart dashboard). Photo: Open drain receiving water from this drainage network (photo: H Steventon)

Considering the flow direction from the gullies (as shown on Figure 8), drainage flows from Gully 7 and above, and Gully 6, partially into Gully 5; drainage from Gully 5 flows to Gully 4 to Gully 3 to Gully 2, from where it discharges into the open drain along Willow Walk (Figure 8). The mean fill depths in these gullies have been compared, and are shown in Figure 18 as both percentage fill and depth of fill.

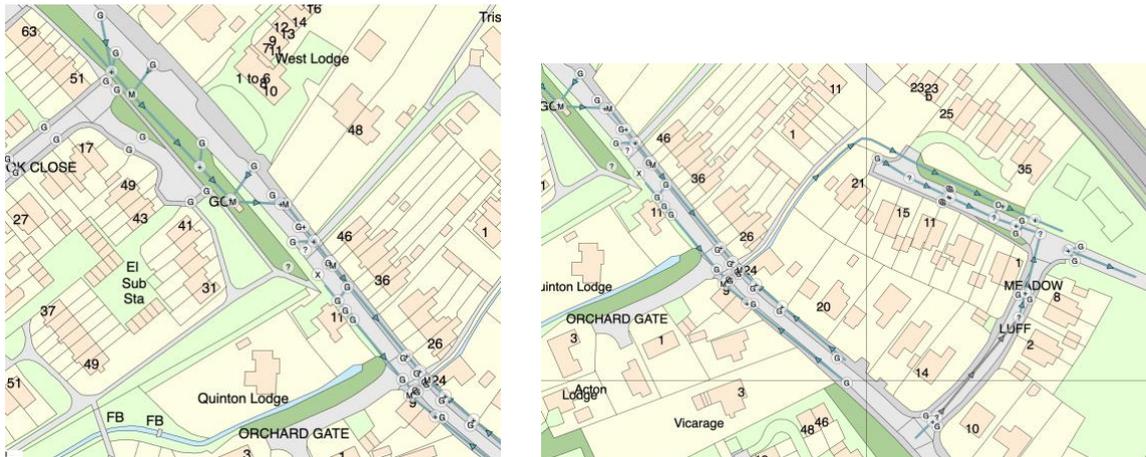
As can be seen in Figure 20, the drainage from this system discharges a group of at least 17 gullies to the north-west of the drainage point, and at least 5 gullies to the south-east of the drainage point, as well as the four gullies at the drainage point. This suggests a total of at least 26 gullies draining through this part of the system. Analysis of fill levels from the sensors installed in gullies in this system indicates that fill levels at gullies in the base of the system can provide usable information for the drainage system, and early indication of growing issues. A suitably located single sensor could indicate operational status for the overall system in general, though not identifying single upstream gullies that have individual blockage issues. This would make the use of sensors in gully management more cost-effective.

Figure 20: Drainage system drained to the north-west and south-east of the drainage point. Images from SCC's KaarbonTech Asset Management System

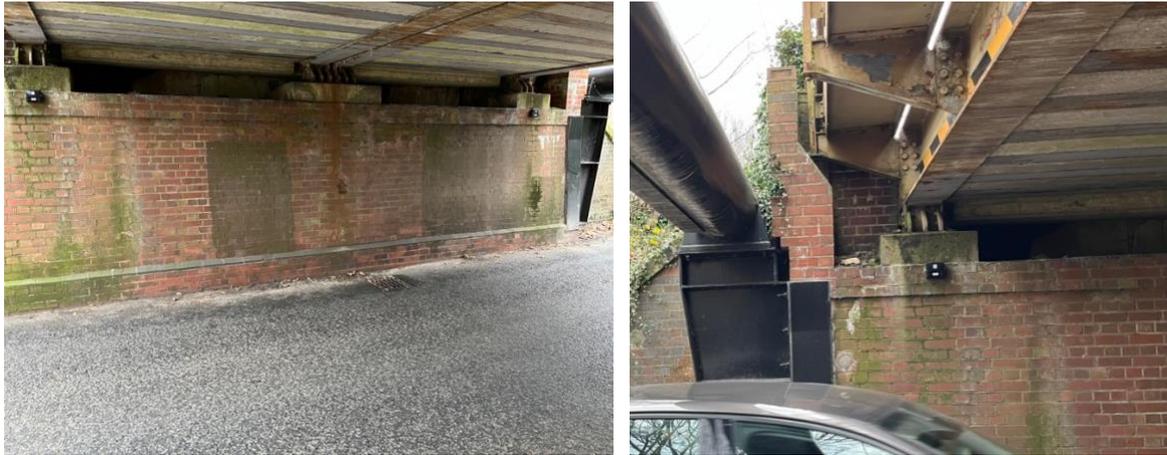
Two sensors were installed under Coddendam Bridge, which carries a railway above a road, and is a known location of occasional flooding relating to weather and drainage. These sensors were installed at a height of 194cm (reported in the online dashboard and downloaded data) as shown in photographs in Figure 22 and Figure 23.

Figure 22: Sensors installed on Coddendam Road Bridge (photographs: H Steventon)
Image on the left shows CRB2 on the left, CRB1 on the right
Image on the right shows potential for car to gutter distance measurement

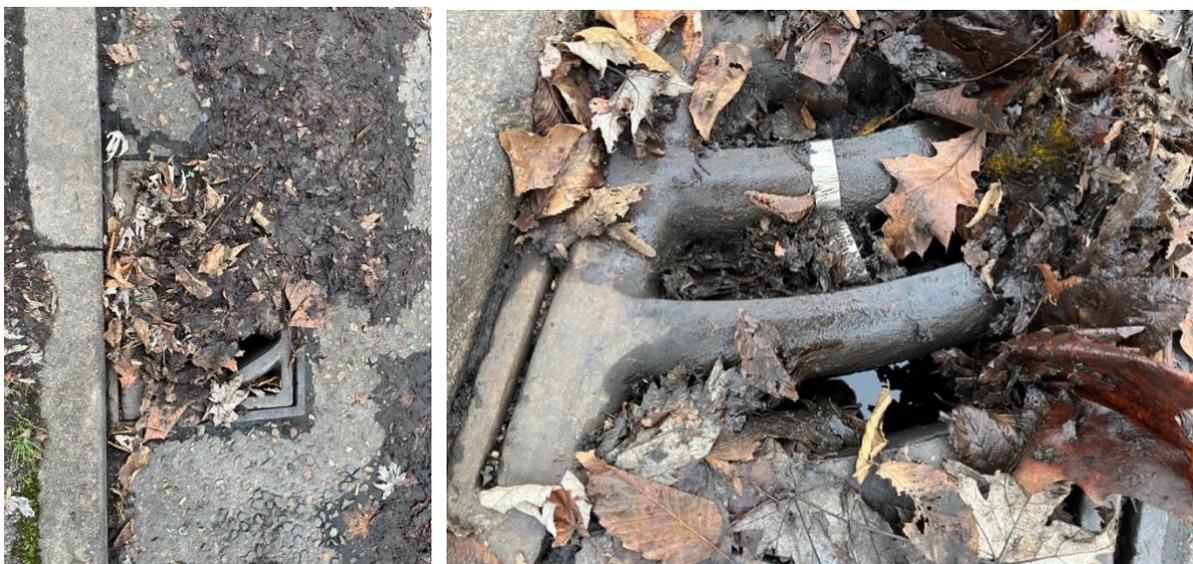
The latest highways inspection (16/08/2021) of this gully as recorded in KaarbonTech’s Asset Management software indicates that the gully was operational with cover described as “ok” and silt levels reported at 50%. On inspection for this report (21/12/2021), the cover was found to be heavily covered with leaves, and the water level very high (Figure 27) and in contact with the lower surface of the device.

Figure 27: Nowton Road Gully 1, as initially located, and after minor leaf clearance to reveal sensor (Photo: H Steventon)

Compared with other gullies in the trial, the water levels in this gully are much closer to the device (as observed during the site visit, and as reported during the period of operation in July 2021), and the device was observed to be in contact with water in the gully when visited. It is suggested that the device likely failed following repeated and / or prolonged periods of submersion, leading to water ingress into the device. It is noted that the devices are IP65 rated, and therefore not rated for prolonged immersion; the overall robustness of the devices installed in gullies in this trial is noted positively.

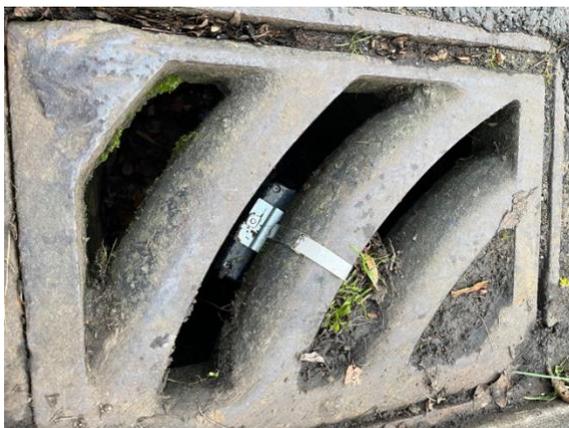
The latest highways inspection (02/09/2021) of this gully is recorded in KaarbonTech’s Asset Management software indicates that the gully was operational with cover described as “ok” and reported as inaccessible. On inspection for this report (21/12/2021), the cover was found to be clear, and the device easily visible (Figure 30).

Figure 30: Mayfield Road Gully 1 (photo: H Steventon, 21/12/21)

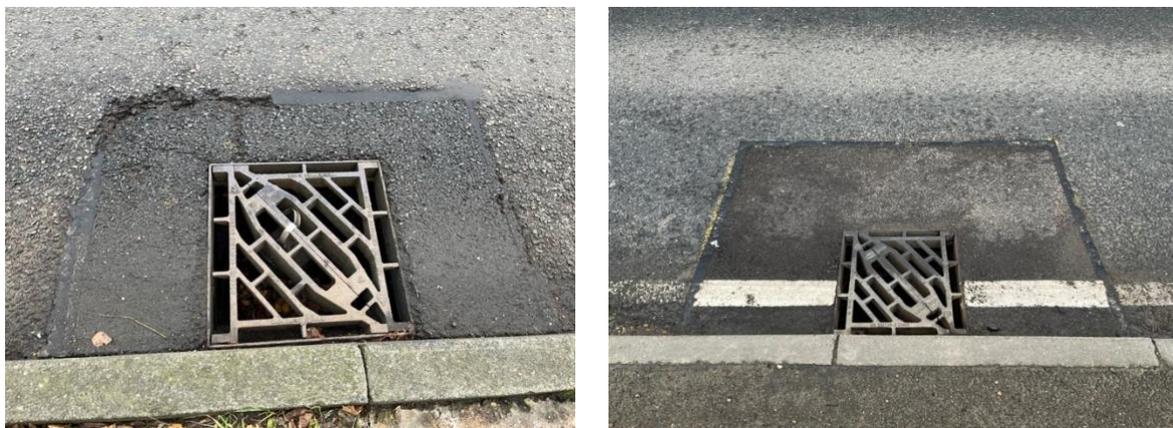
These two sensors are discussed together, as they have both been subject to gully replacement with new gully grate and surrounding road surface (as can be seen in photographs in Figure 32).

Figure 32: Nowton Road Gully 2 (left) and Sicklesmere Road Gully 3 (right) (Photos: H Steventon 21/12/21)

The sensor at Sicklesmere Road Gully 3 (Figure 32 left hand photograph) was not present at time of site visit. It is not known if the sensor was reinstalled when the gully grate was replaced, but has failed since and fallen into the gully, or was removed when the old grate was disposed of.

Location	Postulated reason for cessation of operation
Mayfield Road Gully 1	Unknown
Nowton Road Gully 1	Device failure due to lengthy and / or repeated submersion
Nowton Road Gully 2	Re-installed but ceased to operate during gully replacement
Sicklesmere Road Gully 3	Removed during gully replacement

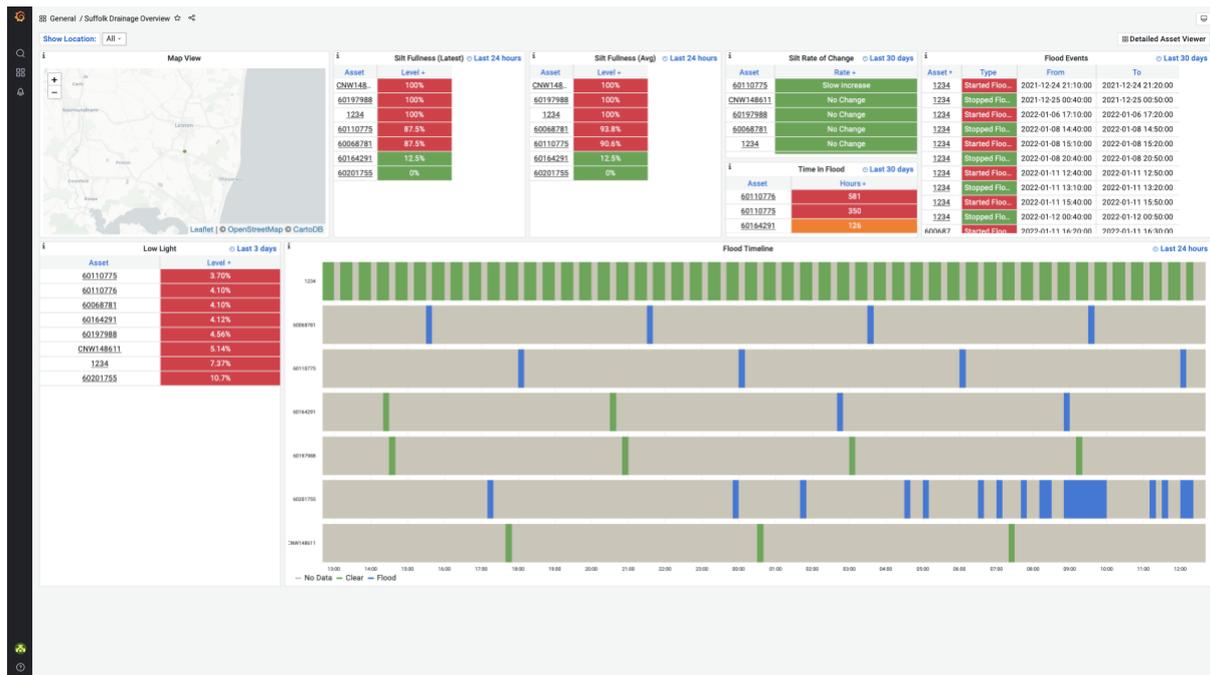
As described in Section 4.3.1, InTouch provide a dashboard, based on a Grafana interface. This dashboard provides an overview visualisation, and a detailed asset view for each sensor. InTouch sensors report silt fill levels, but not depth to water: the sensor head reports flood or not-flood conditions at the height of the sensor head only.

Figure 33: Screenshot of InTouch overview dashboard

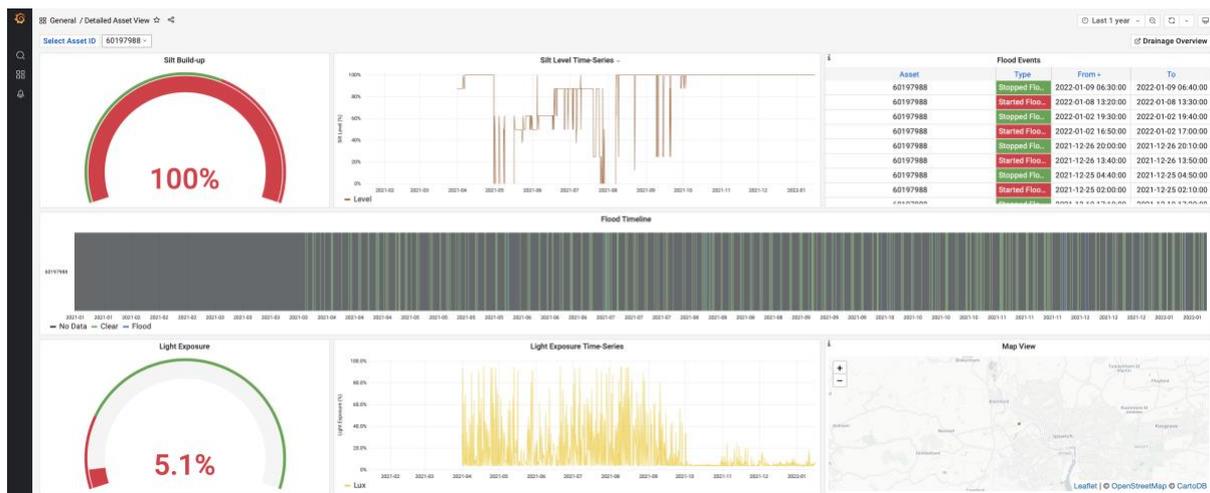
Figure 34: Screenshot of InTouch asset view dashboard

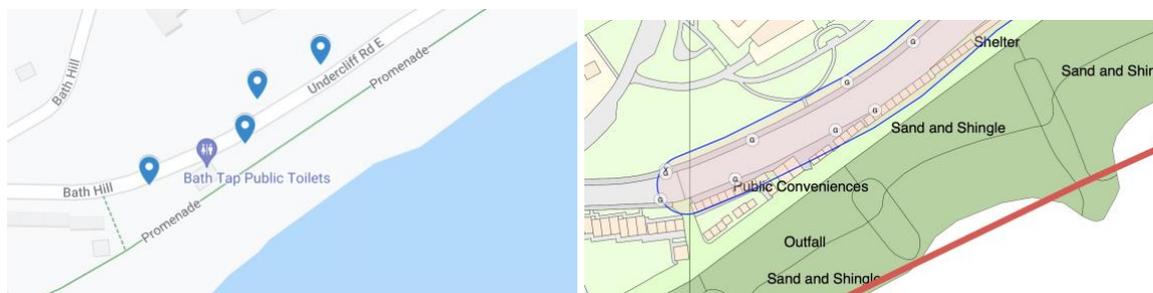
Figure 35: Sensor locations, East Felixstowe, locations plotted from supplied information (left) and KaarbonTech Asset Management Platform (right)

At the time of inspection, these sensors were no longer operational, so measured water and silt levels cannot be compared to reported levels. Sensors appeared to be installed and in position. Three sensors were beneath parked cars with limited access.

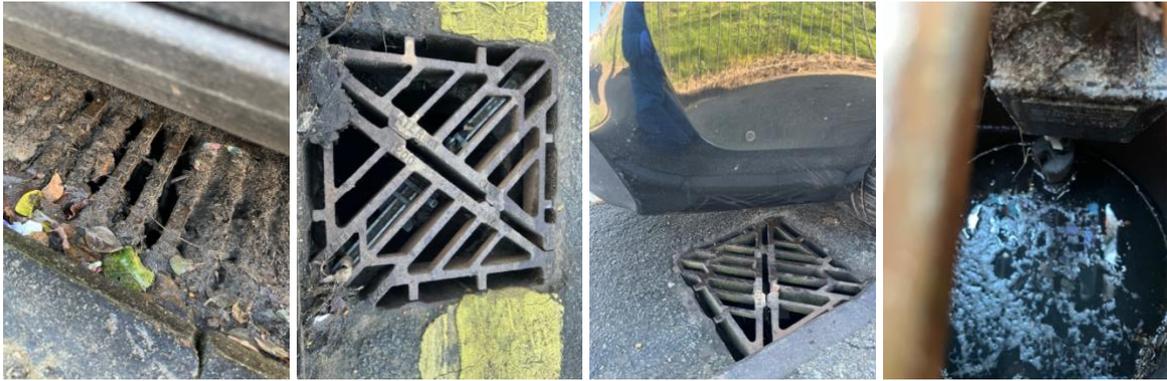
Figure 36: InTouch sensors in East Felixstowe (sensor locations west to east, photos from left to right)

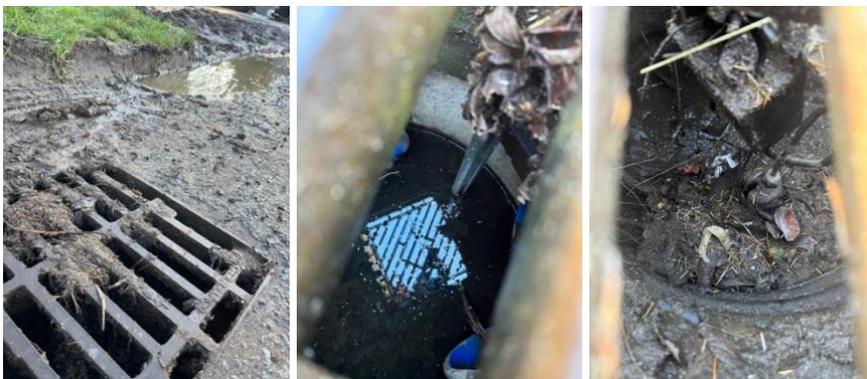
These sensors have never been operational, so measured water and silt levels cannot be compared to reported levels. Sensors appeared to be installed and in position. Deep silt from adjacent domestic construction work was noted in the northern gully pot.

Figure 38: InTouch sensors in Levington (sensor locations north to south, photos from left to right)

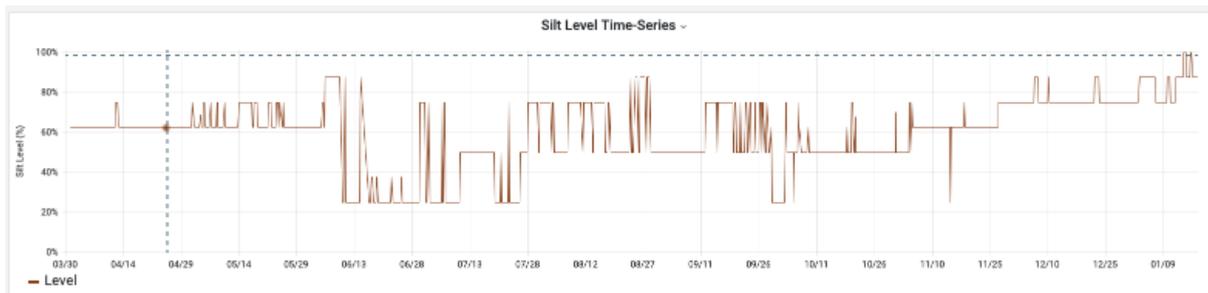
For comparison, screenshots for the silt level indicated by these sensors for the period of operation is included in the following figures (Figure 44 to Figure 46). The quantization visible is due to the technology of silt fill level measurement, with discrete levels of detection. These indicate that variation in silt fill level is indicated by the sensors, but the fill levels observed prior to emptying were not accurately recorded in one of the three sensors.

Figure 45: Silt fill level in sensor 60110775

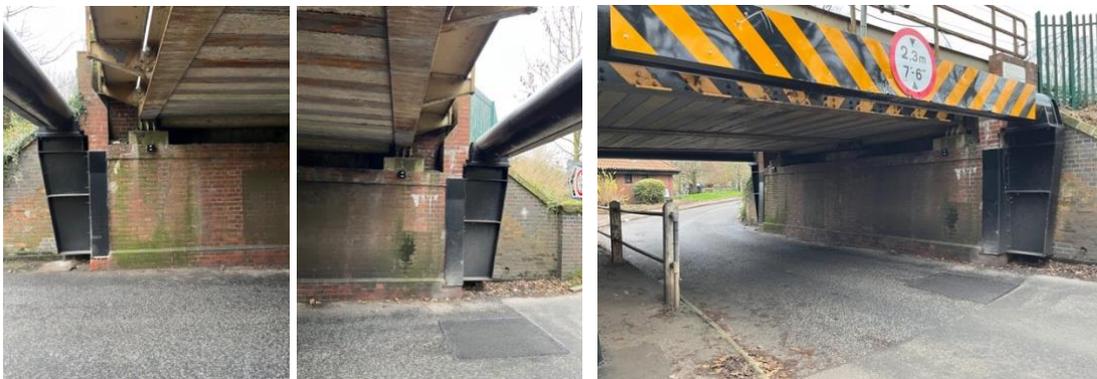
As detailed in Sections 4.2.4, 4.2.5 and 4.2.6, three groups of sensors were examined. Where visible, sensors appeared in relatively good physical condition (Figure 47).

Figure 47: Coddenham Road Bridge sensor 2 (left) and 1 (right). Photos: H Steventon

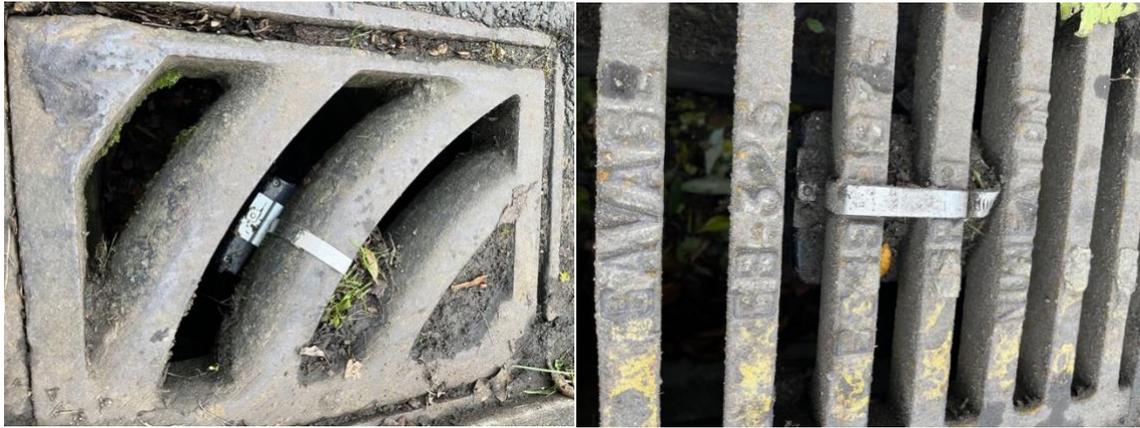
Figure 48: Photos of KaarbonTech sensors showing physical appearance after 6 months installation (photos: H Steventon)

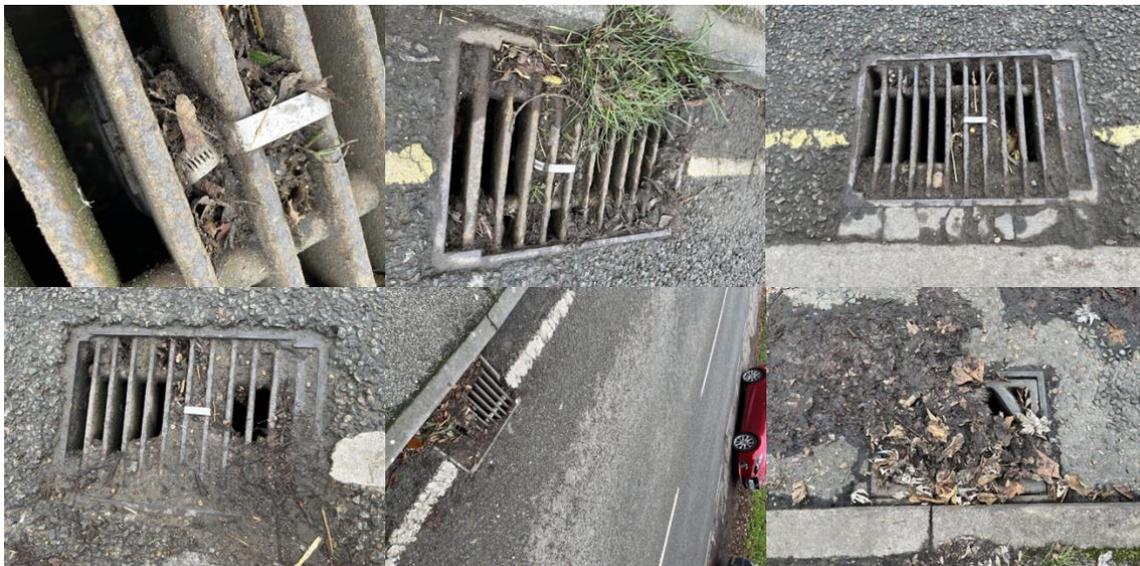
Figure 49: Photos of sensors showing accumulated debris on the sensor installation (photos: H Steventon)

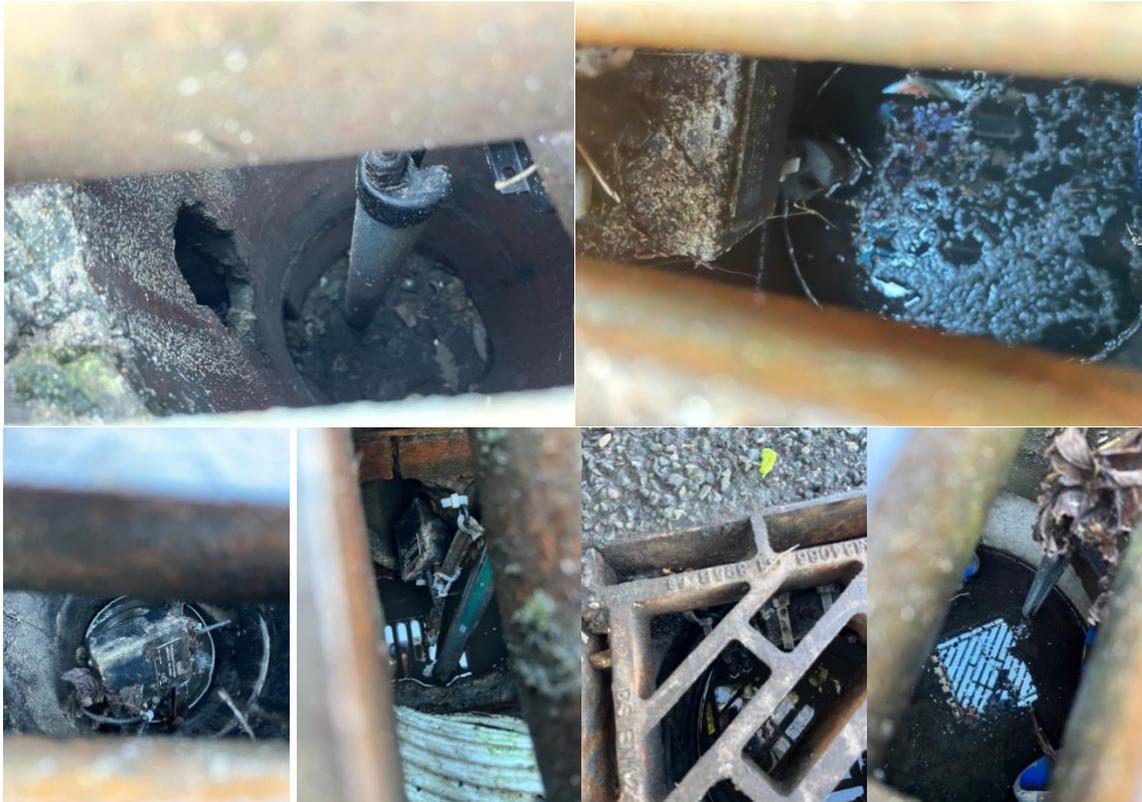
Figure 50: Photos of InTouch sensors showing physical appearance after 9 months installation (photos: H Steventon)

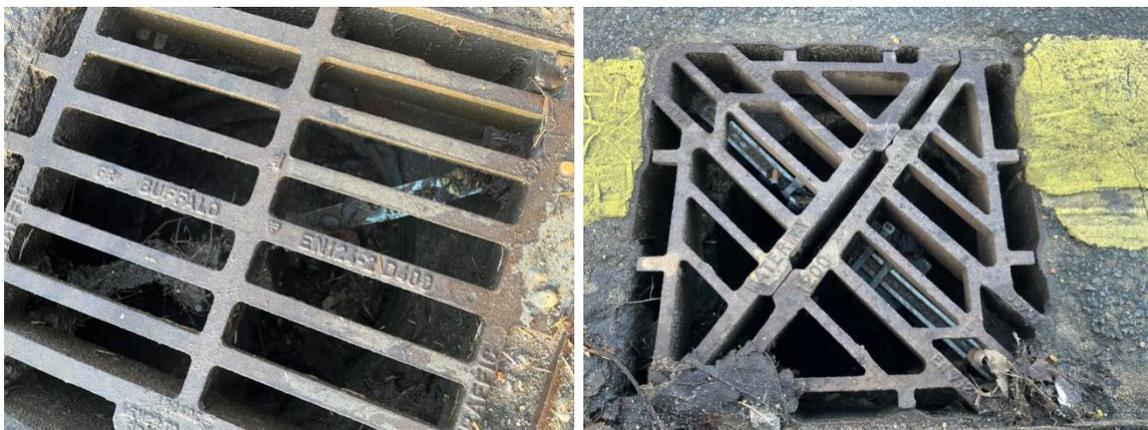
Figure 51: InTouch sensors installed with bar diagonally across gully anticipated to cause problems with gully cleansing.
