Association of Directors of Environment, Economy, Planning & Transport

Guidance Note on the treatment of melted Surface Dressed roads

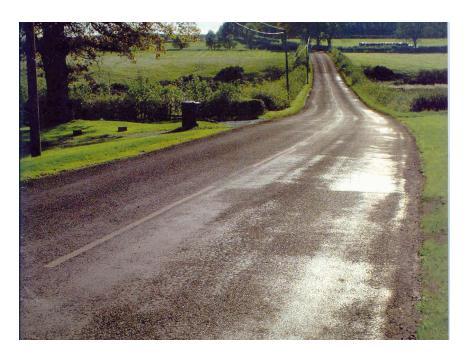
As a result of this fatting up of the surface occurs leading to;

- Poor skid resistance in the dry and possibly dangerous levels when wet
- Pick up of binder on car and cycle tyres and by pedestrians
- Surface deformation in the wheel tracks which could potentially hold water – this may not always occur if the traffic levels are low
